RCRA FACILITY ASSESSMENT REPORT

Asheville Dyeing and Finishing Co./Anvil Knitwear NCD070619663

850 Warren Wilson College Road
Swannanoa, NC 28778

July 29, 2004

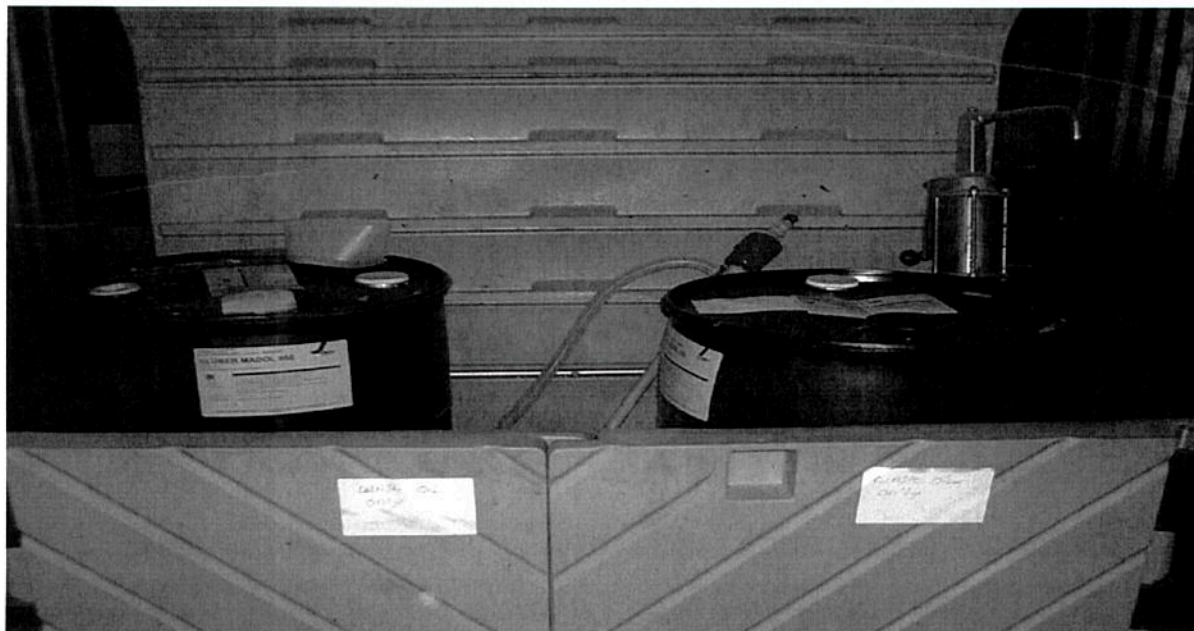
Photo Number: 14
Direction: Facing east
Description: Two 55 gallon drums stored inside Used Knitting Oil Secondary Unit (SWMU 3)

The used knitting oil storage area consists of a polyvinyl chloride (PVC) drum storage cabinet providing secondary containment located near the northeast corner of the Knitting Room. At the time of the VSI, the cabinet contained two plastic 55-gallon drums designated for the accumulation and storage of used knitting oil. Both drums were closed, and the cabinet was closed during the VSI. The drum storage cabinet was labeled with the words "waste oil only." The drum storage cabinet and plastic drums appeared to be in good condition with no visible leaks or evidence of past leaks. The unit is located on the concrete floor of the Knitting Room and does not have any cracks or scars (Reference No. 4).

RECOMMENDATION:	No Further Action	(X)
	Confirmatory Sampling	()
	RFI Necessary	()

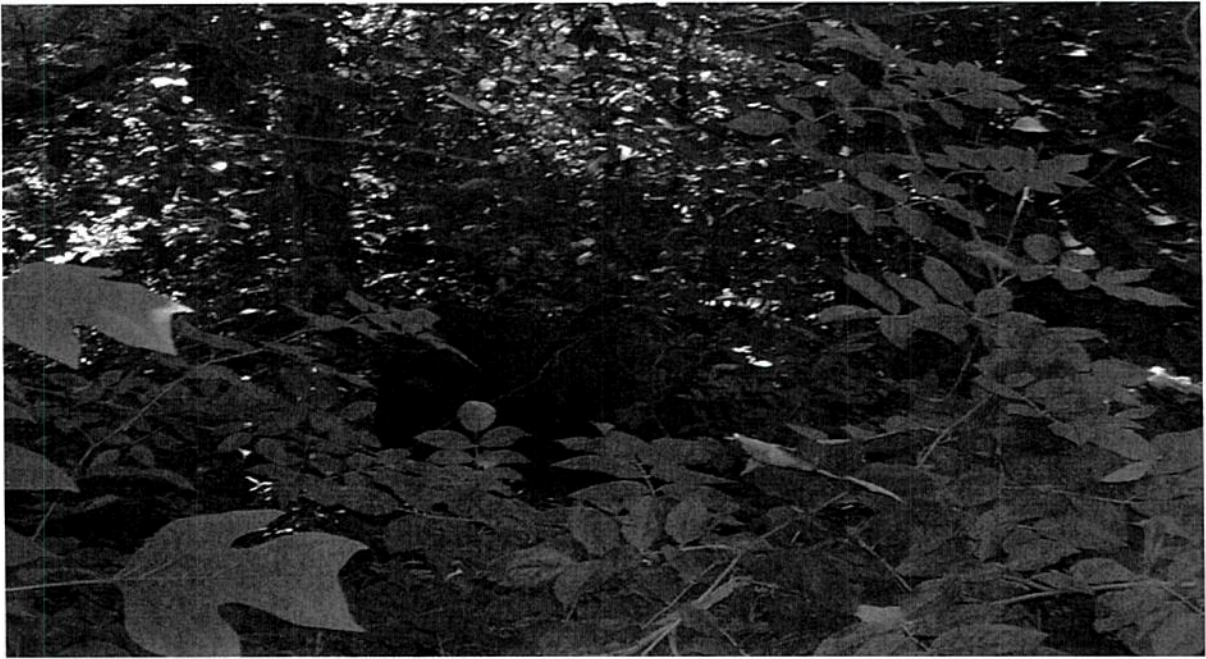
Photo Number: 35

Description: Partial 55 gallon drum that is located in the Old Dump Area (SWMU 14)

¹ An RFI is recommended for this unit. Based on the visual site inspection of this area dated April 3, 1986, and the groundwater samples collected during the September 1994 investigation, there is reason to believe that this area contains wastes that continue to be a potential threat to the environment. Further investigation is recommended to fully characterize the nature and extent of this contamination.

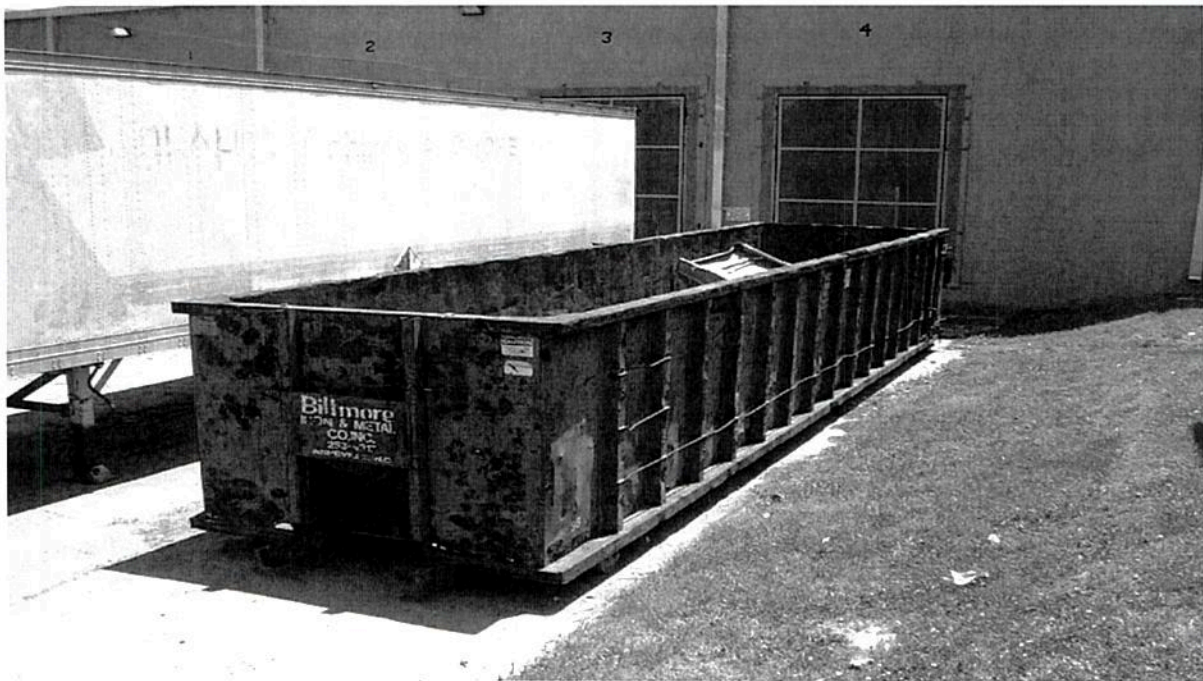
Photo Number: 36

Description: Roll-off container located on the north side of the manufacturing building (SWMU 15).

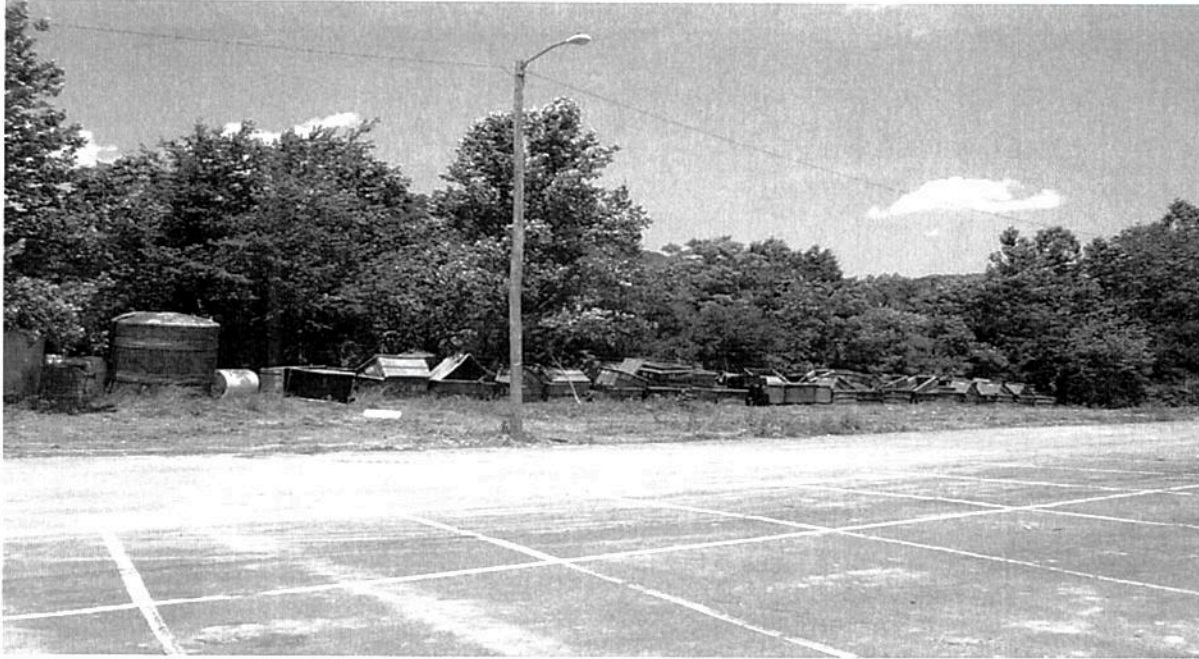
Photo Number: 37

Description: Storage Area containing plastic waste handlers, metal tanks, and one fiber glass tank. This area is located adjacent to facility north fence line (SWMU 23)

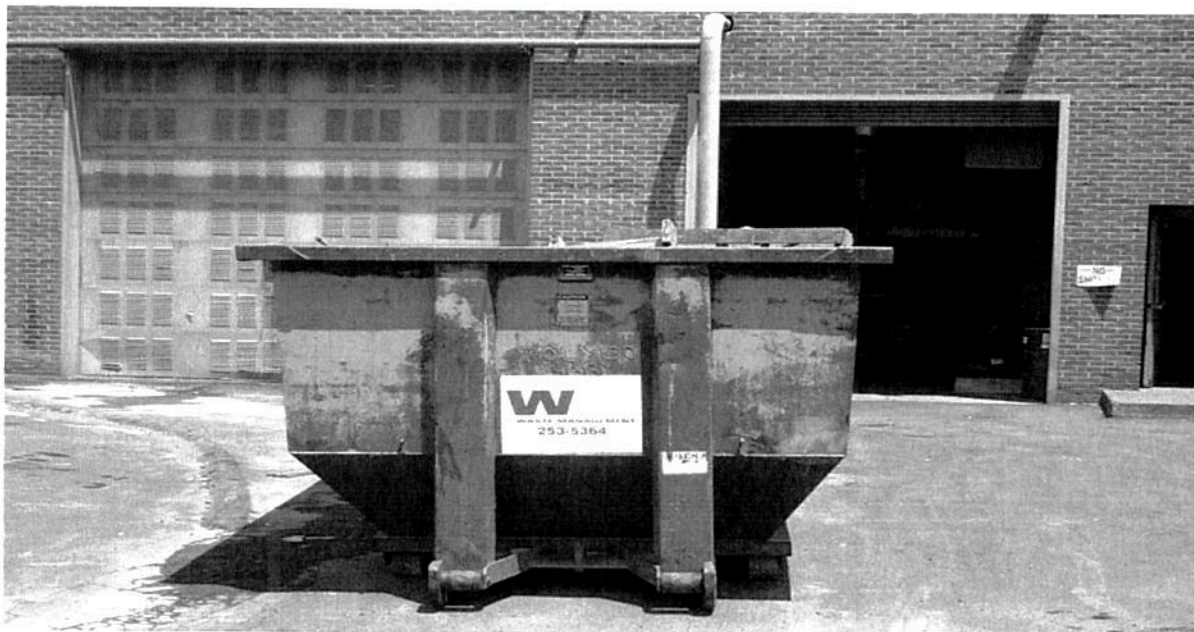
Photo Number: 41

Description: Roll-off container located on the west side of the manufacturing building (SWMU 19)
